POWERLINK QUEENSLAND DRAFT REVENUE PROPOSAL

CP.xxxxx
Calvale Selective Primary Plant
Replacement

SITE CONDITION ASSESSMENT REPORT

H024 CALVALE

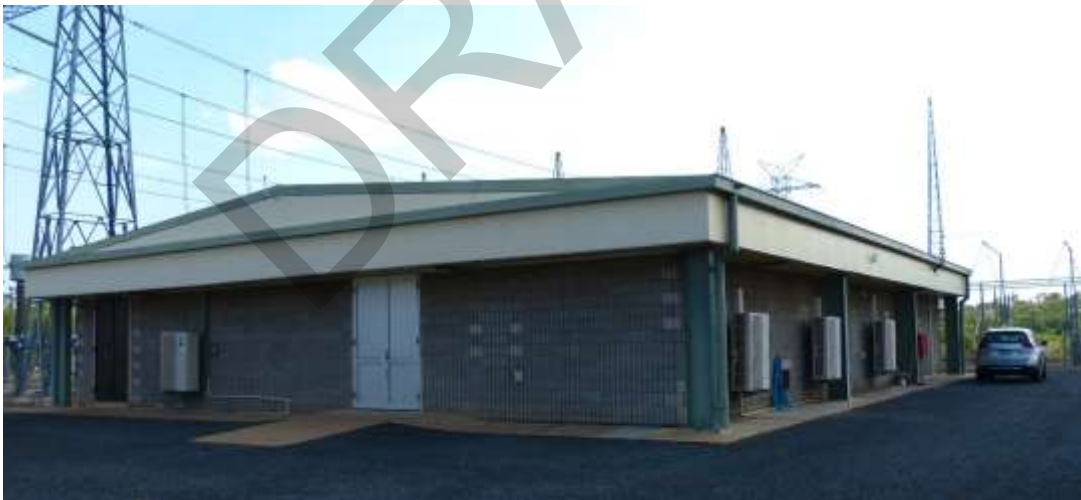
Figure 5: Control Room Building

There is one control building and a shed on this site. The original control building is brick construction with a steel metal roof and was commissioned in 1987. This building houses Powerlink 275/132kV control panels, the 125V and 50V DC supply systems and telecommunication equipment. It consists of a control/relay room, communications room, battery room, amenities room and toilet. The control, battery and comms rooms are all air conditioned. The majority of windows have bars installed. The building is reasonably well maintained and no significant issues were noticed. shown in Figure 5.

Recommendation: Based on the condition it is recommended that this brick building is fit for purpose for another 40 years with regular maintenance.

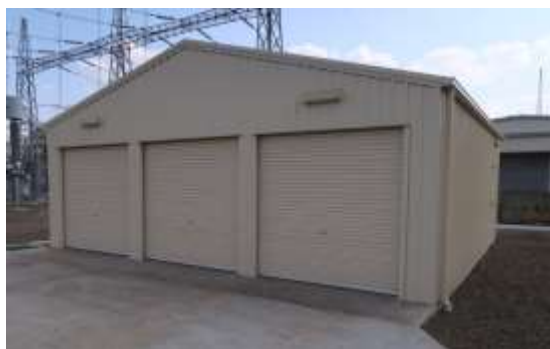
Figure 6: Storage Shed

A storage shed is located in vicinity of the control building. The shed exterior is in good condition and no issues were noted. See Figure 6.

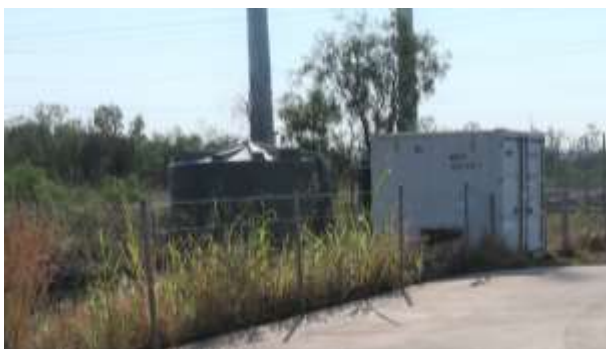
Figure 7: Water Tanks at wash-down station

There are no permanent water tanks within the yard. Two water tanks are positioned outside the yard at the wash-down station. The tanks are made from polyethylene and are in good condition. See Figure 7

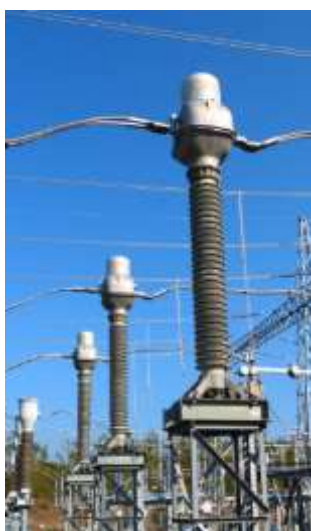
Figure 8: CT's

The Haefely oil filled current transformers are in satisfactory condition considering they have been in service for 33 years, and the DGA/moisture in oil analysis is satisfactory. There are no identified issues with oil seal integrity. Current transformers with paper and oil insulation within a porcelain housing have been found to have an increased probability of explosive failure after 36 years in service, with potentially catastrophic safety consequences. Considering their age and construction, it is recommended to replace these in 5 years.

Recommendation: Based on the above observations, it is recommended that CB and CT incl. structures and foundations are replaced within the next 5 years preferably using dead tank CB. The rest of the HV plant is in good condition and no replacements are required in the next 10 year outlook.

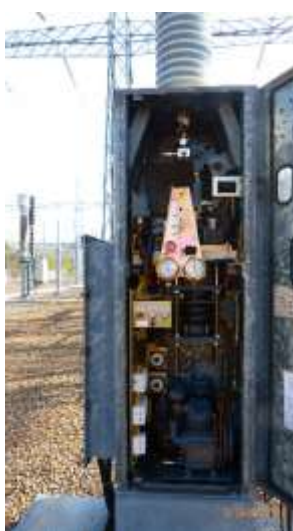
Figure 9: CB Mech box

The circuit breaker in this bay is a Mitsubishi 250–SFM-340B manufactured in 1987 and installed in 1988. It has pneumatic operating mechanism with air and spring used for energy storage and SF6 gas for insulating medium. SFM type Mitsubishi CBs of this vintage have asbestos impregnated washers of friable nature associated with the heater inside the mechanism box. Mitsubishi does not produce this type of circuit breaker anymore and sourcing of spare parts has become a major issue. Wiring inside the mechanism box is cracked due to UV penetrating through viewing window.

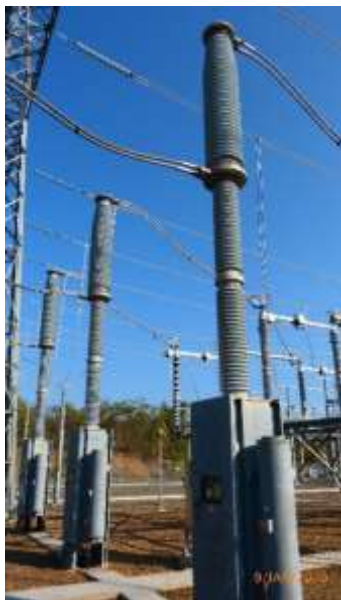
Figure 10: CB

the heater inside the mechanism box. Mitsubishi does not produce this type of circuit breaker anymore and sourcing of spare parts has become a major issue. Wiring inside the mechanism box is cracked due to UV penetrating through viewing window.

Maintenance records show minor issues with wiring inside the mechanism box is cracked due to UV penetrating through viewing window and shielding installed on the cables to prevent UV damage. This CB has been in service for 33 years and it is estimated that it has a remaining service life of 5 years.

Recommendation: Based on the above observations, it is recommended that CB, CT and CVT including structures and foundations are replaced within the next 5 years, preferably using a dead tank CB. The rest of the HV plant is in good condition and no replacements are required in the next 10 year outlook.

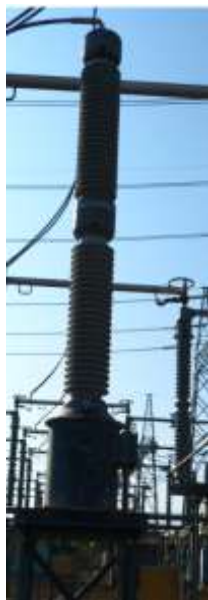
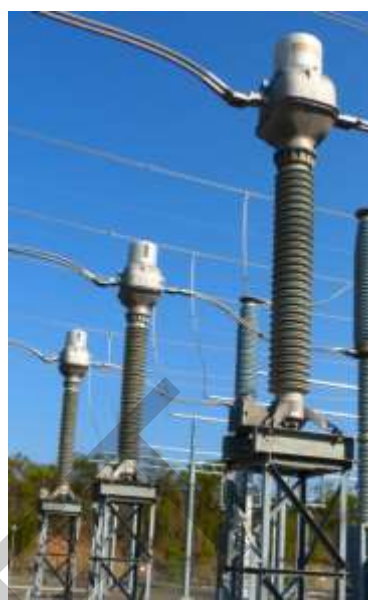
The A phase CT was replaced in 1997 and appears to be in an acceptable condition. The remaining oil filled instrument transformers are in reasonable condition considering they have been in service for 33 years, and the DGA/moisture in oil analysis is satisfactory. There are no identified issues with oil seal integrity. However, considering their age and construction, it is recommended to replace all CTs and the CVT in 5 years to manage potential safety risks.

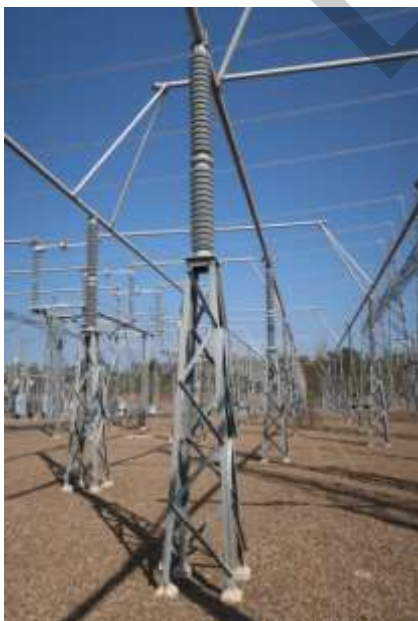
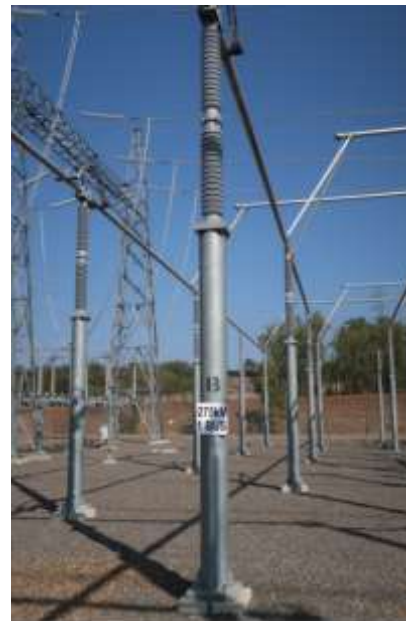
Lattice structures were used as bus supports in the initial construction while in the late 1990s and 2000s tubular structures were used. All structures are in good condition and no significant issues were found. Examples of the lattice and tubular structures are shown in Figures 15 and 16 respectively.

Recommendation: The corroded bolts on all structures are recommended to be replaced immediately. Apart from this, based on the above observations, the primary equipment in these bays is in good condition and no replacements are required in the next 10-15 year outlook.

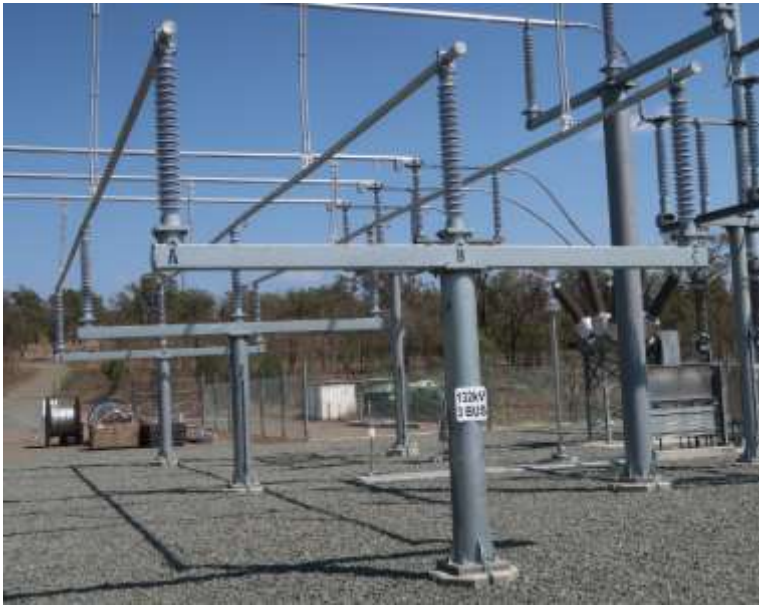
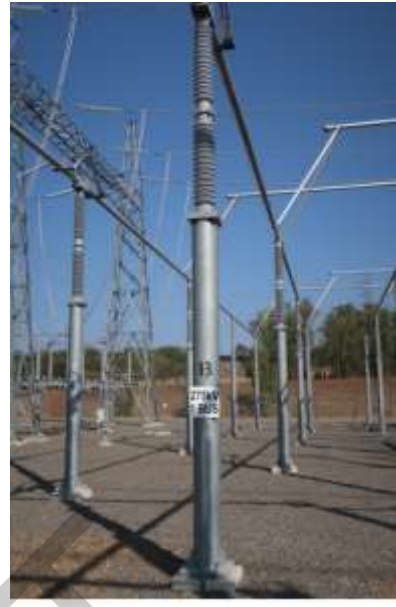
The 132kV bus support structures were established in 2019 and are in as new condition. The structures support all three phases as shown in Figures 17 and 18.

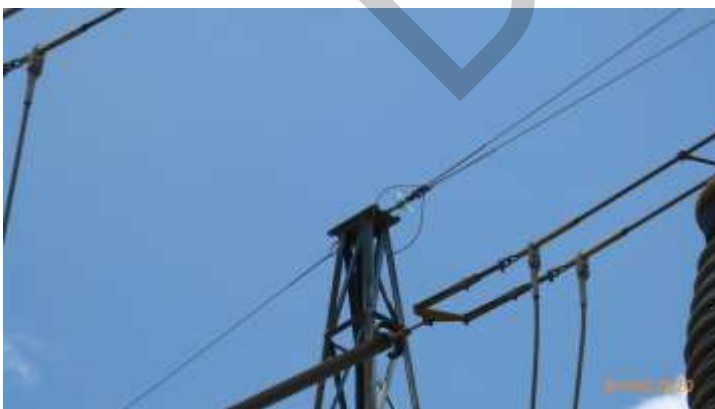
Figure 19: Earth wire

The overhead earth wire appears to be in good condition. The connections of the earth wire to their strain towers vary in configuration but these are also in good condition. Refer to Figure 16 and 17

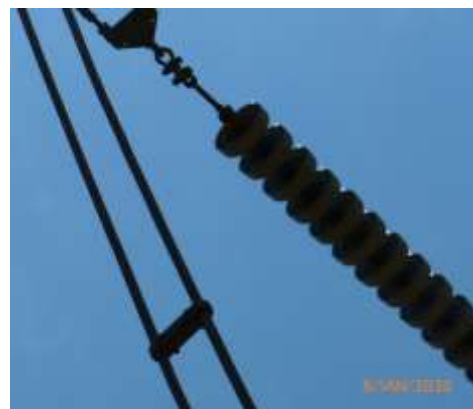
Figure 20: strung bus conductors

From ground level both 275kV & 132kV strung bus conductors and connectors over the bays appear to be in good condition.

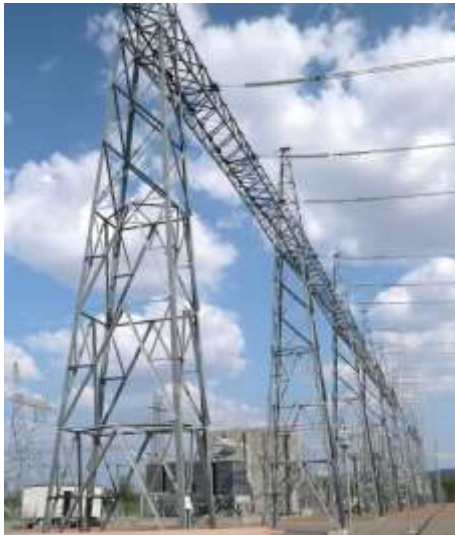
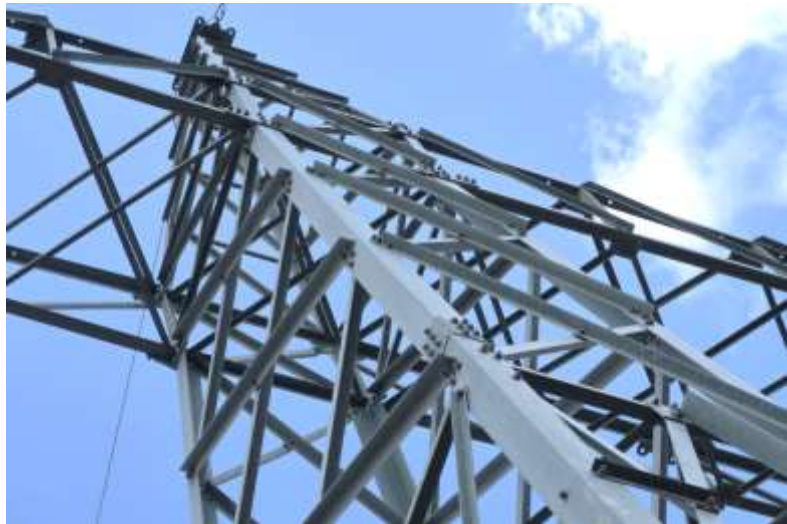
The 275kV strain structures were established between 1984 and 2013. All 275 kV strain structures are the same lattice type as shown in Figures 18 to 19. No issues related to the structures were found.

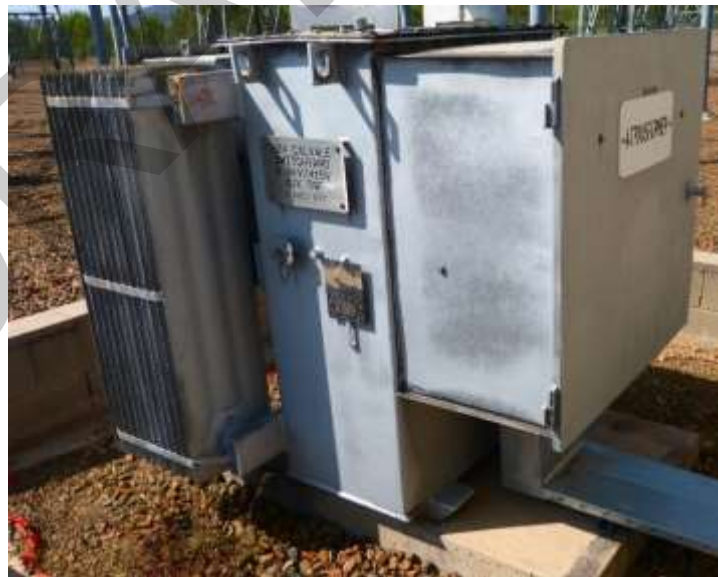
Figure 24: 4 Stn Transformer

These two station transformers are in good condition. However the 4 station transformer is 44 year old and is at the end of its technical service life where condition is expected to deteriorate rapidly.

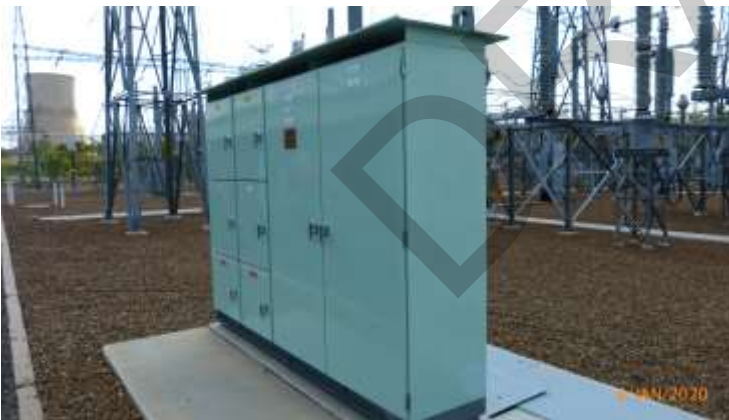
Figure 26: AC changeover board

The AC changeover board was installed under project CP.01151 and is in good condition.

Recommendation: Based on the above observations and records, there is no action required in the next 10 years outlook, apart from normal maintenance.

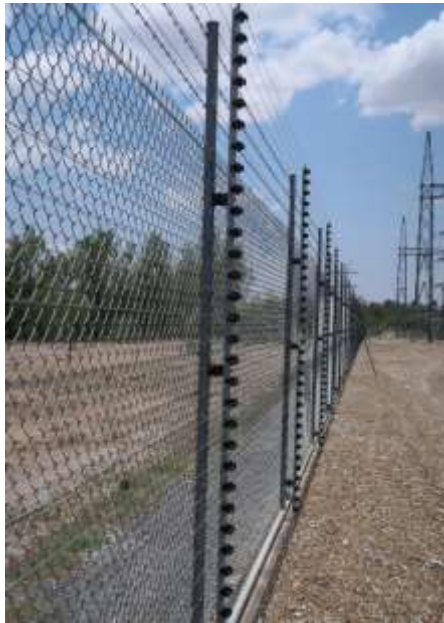
Figure 27: Security Fence

The substation security fence consists of a standard chain wire fence and an electrical fence mounted on the inside of the chain wire fence. The chain wire fence is approximately 3m tall, has a bottom rail and barbed wires at the top. At the base of the fence is a concrete strip in line with Powerlink's standard requirements. The fence is in good condition and its civil aspects should provide about 20 year life before significant repairs are required. A section of the fence is shown in Figure 27.

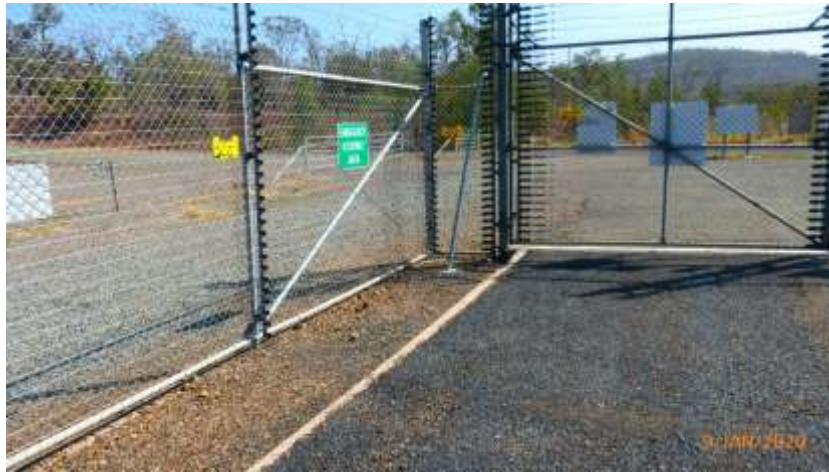
Figure 29: Broken road surface

The substation internal roads are in a reasonable condition although broken in some areas. In particular the road surface is broken in the vicinity of the entry gate as shown in Figure 29.

Recommendation: Based on the above observations and records, there is no action required in the next 10-15 year outlook, apart from normal maintenance.

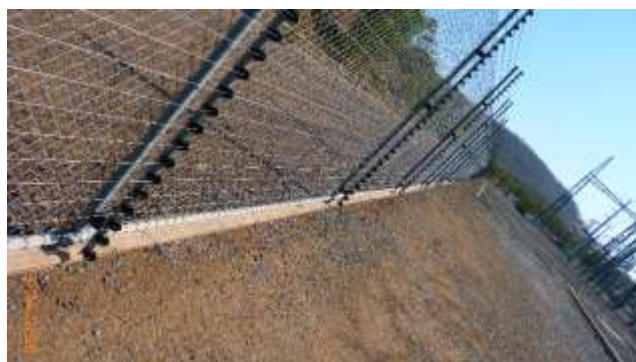
Figure 30: no tail to fence

The fence post should be connect to the main earth grid at the grid crossings, it was noticed on site that this was not the case.
