Cultural heritage due diligence assessment

Theodore Wind Farm Connection Project

Due Diligence Assessment

Prepared for WSP | 17 October 2025

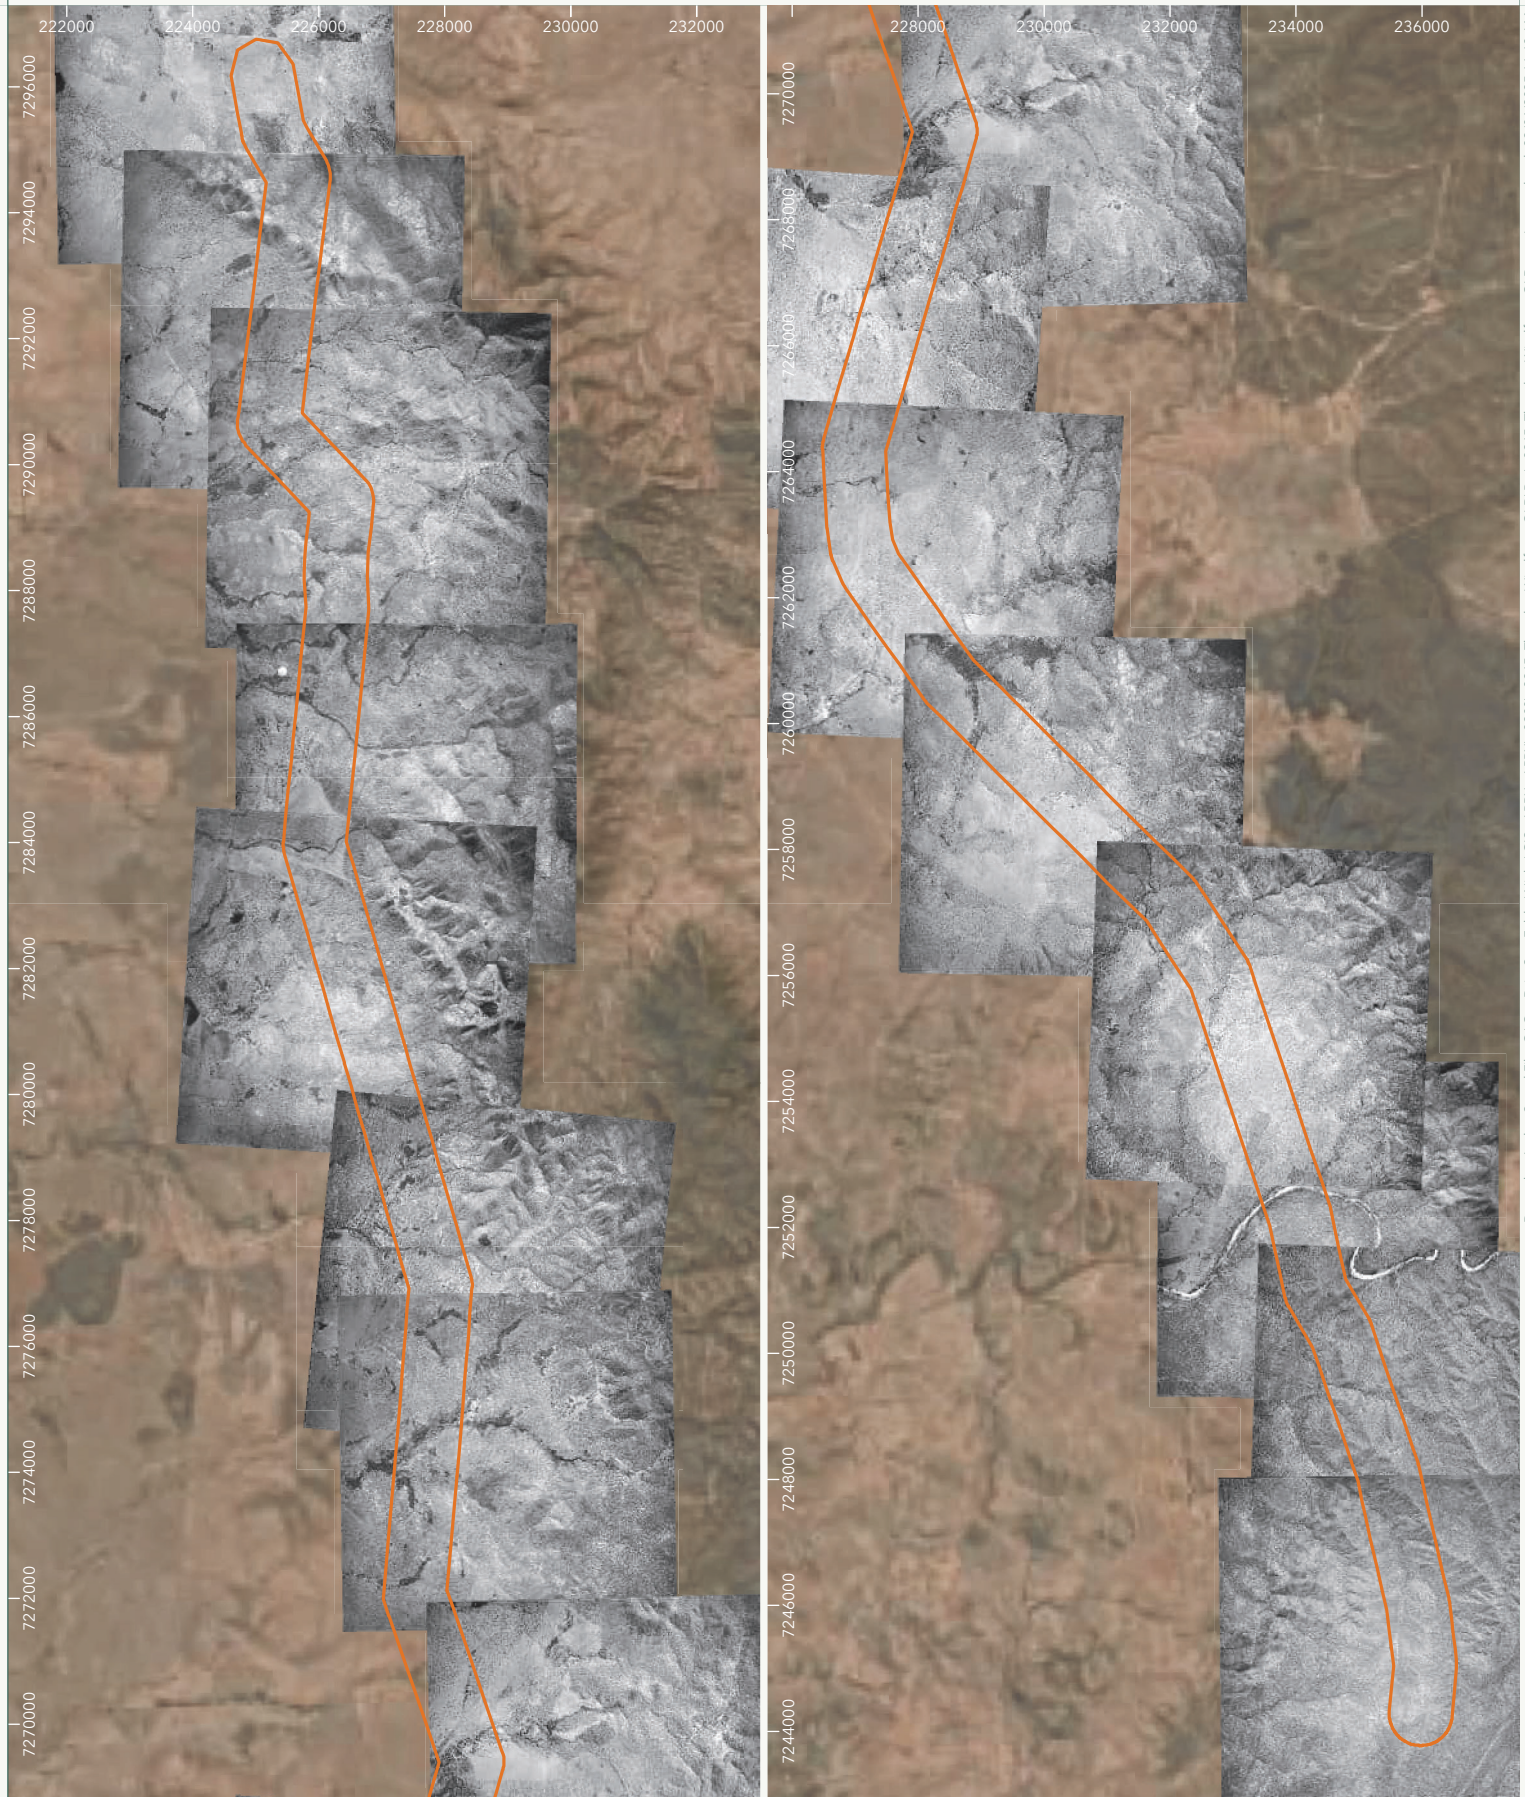
Figure 2-1
Historical Aerial Imagery Assessment (1960)
 Theodore Wind Farm

Aerial imagery covering the Project area that shows past land use and disturbance is available from the 1960s-2000s. Observations of land use and disturbance for the key available periods are seen in Figure 2 and are summarised below in Table 3.
