POWERLINK QUEENSLAND DRAFT REVENUE PROPOSAL

CP.xxxxx
Calvale Selective Primary Plant
Replacement

SITE CONDITION ASSESSMENT REPORT

H024 CALVALE

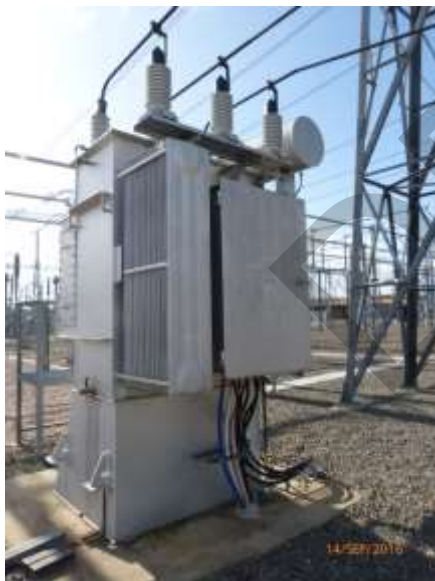
Figure 23: 3 Stn Transformer

These two station transformers are in good condition. However the 4 station transformer is 44 year old and is at the end of its technical service life where condition is expected to deteriorate rapidly.

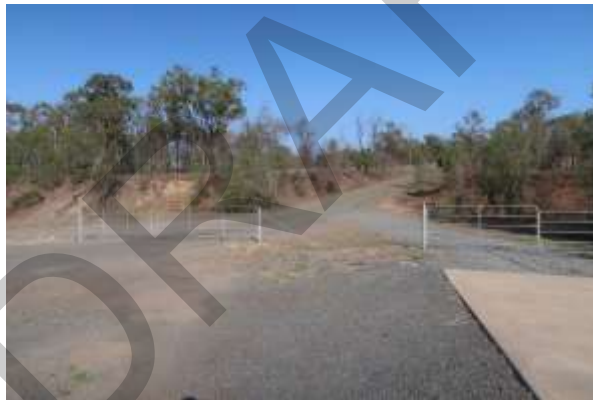
Figure 28: Substation access from Biloela Callide Rd

The Calvale Substation is accessed from Biloela Callide Rd, Biloela. This is a suburban road with good visibility of the entrance shown in Figure 28.

The access road through Powerlink's property between the road gate and the substation security gate is sealed and in good condition. The security gate and fence were not inspected due to the planned security fence upgrade project.

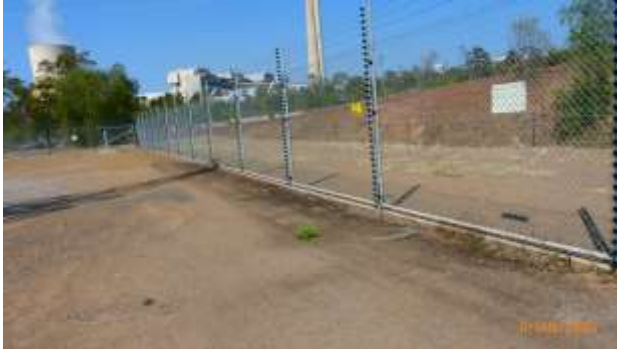
Figure 31: Gravel in the yard

A grid injection test was performed in August 2018 and the results were satisfactory. However the earth grid design report (objective ID A2984746) recommended that gravel surfacing be completed inside the north eastern fence and the south western gate and an asphalt strip placed outside these areas as a minimum and ideally gravel throughout and the asphalt around the entire yard. It appears that this recommendation was not done. The current gravel layer installed inside the substation appears to be for current plant maintenance strategies not for earthing.
