# Appendix D

Aquatic ecology technical memo

# Technical Memo: Meandu Mine Transmission Line Relocation, Aquatic Ecology Assessment

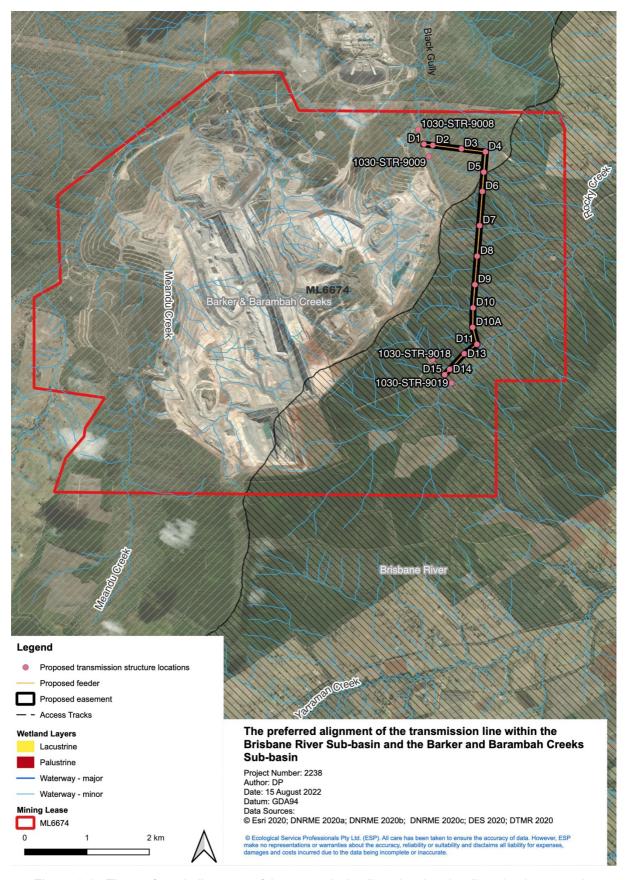
Figure 1.1 The preferred alignment of the transmission line showing the diversion between the Brisbane River sub-basin and the Barker and Barambah Creeks sub-basin

The existing Feeder 831 is a 275kV transmission line between the Tarong and Middle Ridge substations owned and operated by Powerlink Queensland (Powerlink). It is located immediately to the east of Meandu Mine, which is owned and operated by TEC Coal Pty Ltd (TEC Coal), a wholly owned subsidiary of Stanwell Corporation Limited (Stanwell). A portion (approximately 5 km) of the Feeder 831 transmission line is proposed to be relocated (the Project). Relocation of this portion of Feeder 831 is required to safely accommodate proposed mining activities at the Meandu Mine, which requires that a section of land underneath this line is mined. Stanwell are also investigating an additional surface area to Meandu Mine within this locality, referred to as the King 2 East (K2E) Project. Planning for relocation of the portion of the transmission line has been undertaken with consideration of the K2E Project. The preferred alignment of the proposed Project is located within the Upper Brisbane River sub-basin and the Barker and Barambah Creeks sub-basin of the Burnett River Basin (Figure 1.1).

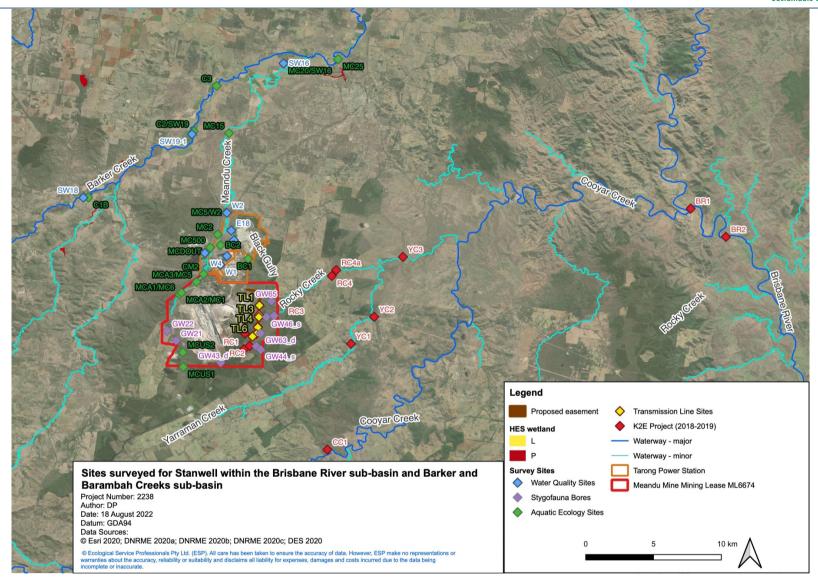
Figure 1.2 Sites surveyed for Stanwell within the Brisbane River sub-basin and the Barker and Barambah Creeks sub-basin

Sites previously surveyed for in these assessments for are shown in Figure 1.2.

Aquatic habitat assessment site locations are detailed in Table 1 and shown in Figure 1.2.

Twelve monthly water quality sampling events between April 2018 and March 2019 as well as sediment quality sampling in April and September 2018 were completed for the Meandu Mine K2E Project (ESP 2021). During these surveys, the upstream waterway sites on Rocky Creek (sites RC1, RCT1 and RC3 on Figure 1.2) were dry during all sampling events. These sites are likely to flow for a very short time and are unlikely to hold water following rainfall.

A stygofauna pilot study was completed at 10 bores in the vicinity of the Project in June 2019 as part of works undertaken for the K2E Project (refer to Figure 1.2 for bore locations; ESP 2021). No stygofauna were recorded from bores during the pilot study.

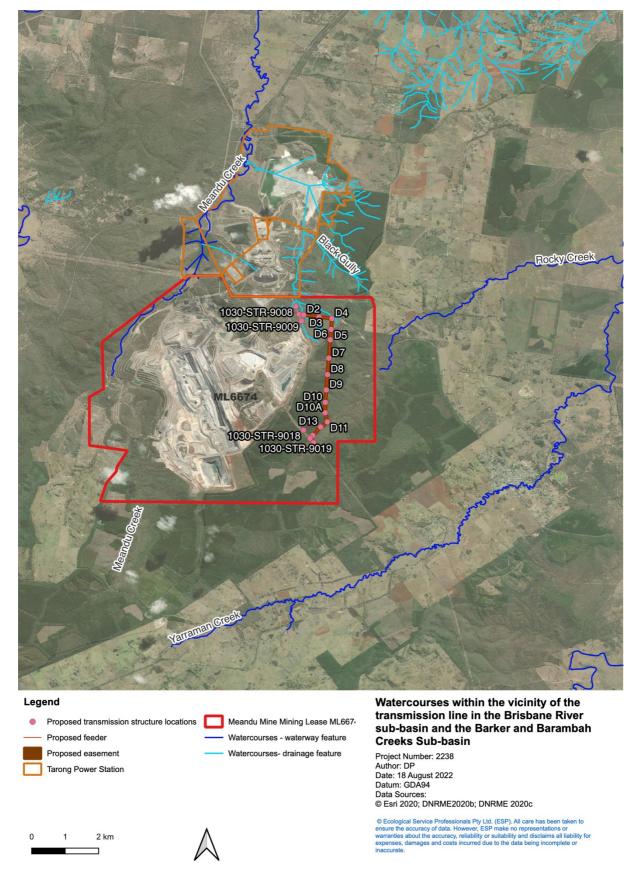
Figure 2.1 Mapped watercourses within the vicinity of the transmission line

Black Creek was de-gazetted as a watercourse in 2000 under the Water Act by the former DNRME. It is now mapped as a drainage feature (Figure 2.1). The unnamed tributaries of Black Creek crossed by the preferred alignment are mapped as stream order one and two waterways. Approximately 320 m downstream of the transmission line, Black Creek is an order three waterway, and approximately 450 m downstream, it is an order four waterway, which extends to Black Creek Dam. The upper tributaries of Black Creek are not mapped as GDEs, with the closest mapped (moderate) potential GDE located approximately 1.6 km downstream (Figure 2.2). Shallow groundwater flow within the Black Creek catchment is likely to occur within the shallow Tertiary Regolith, where discharge to surface may occur towards Black Creek Dam. Although there are two mapped lacustrine wetlands within Black Creek catchment, these are artificial dams that form part of the water management system for Meandu Mine and the Tarong power stations (Figure 2.3). There are no HES wetlands within the Black Creek catchment, with the closest located approximately 16 km downstream of the Project.

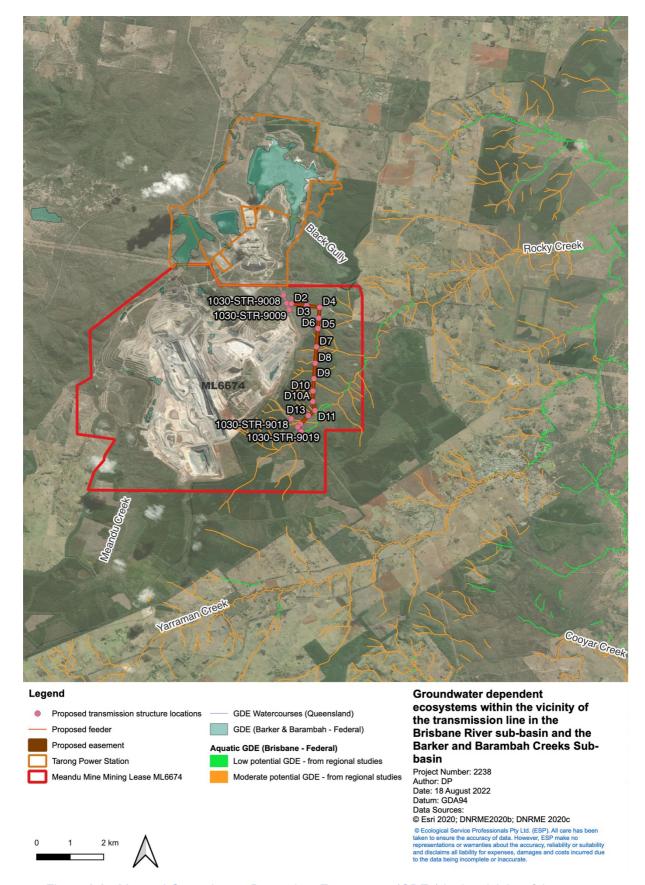
Figure 2.2 Mapped Groundwater Dependent Ecosystems (GDEs) in the vicinity of the transmission line

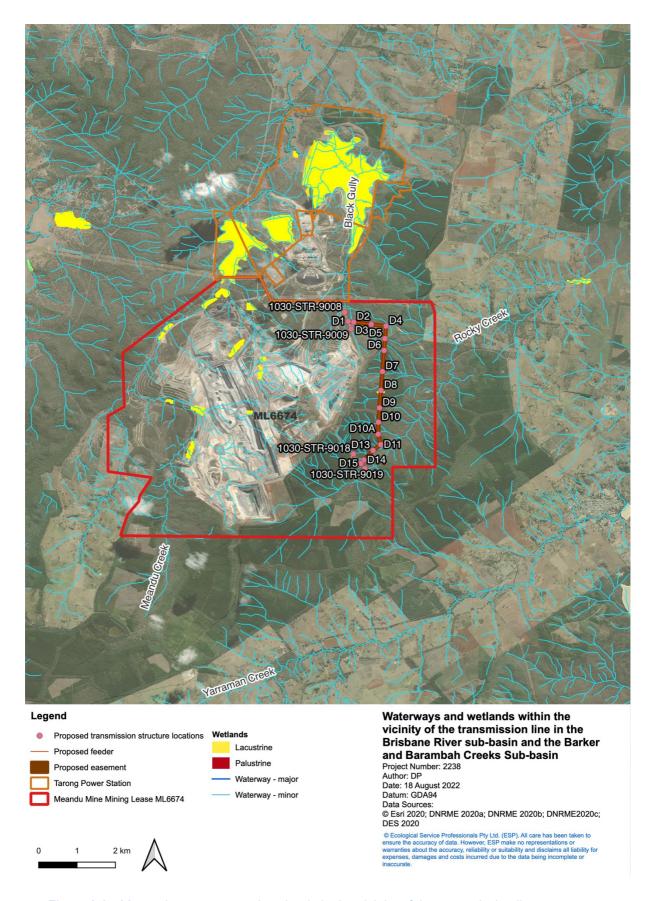
Figure 2.3 Mapped waterways and wetlands in the vicinity of the transmission line

The section of new access tracks between structures D1 and D5 crosses an upstream waterway of Black Creek (between structures D1 and D2; refer to Figure 2.3). This section of Black Creek is stream order two and likely to be of low ecological value. Aquatic habitats, flora and fauna are likely common and typical of the region, and immediately downstream the waterway forms part of the Meandu Mine and Tarong power stations water management systems. As such, potential impacts to the aquatic ecology from the new access track between structure D1 and D5 are expected to be minor.

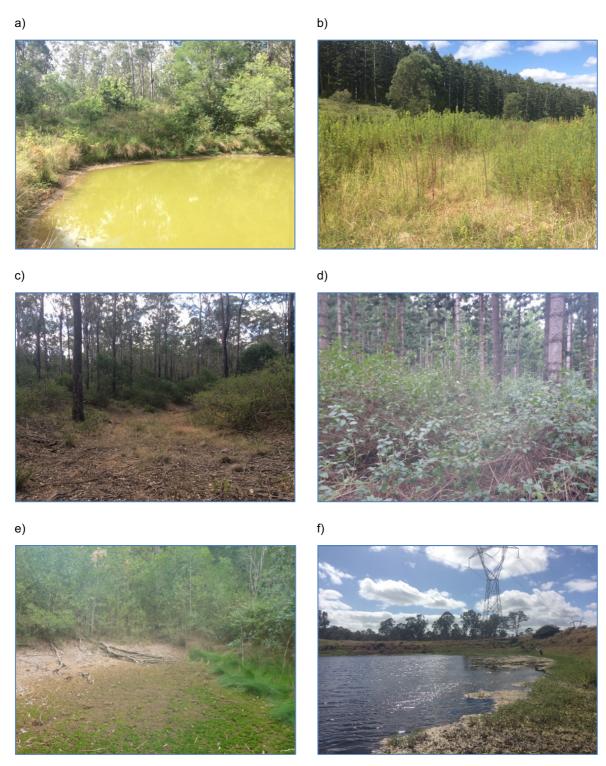
Figure 2.4 Photographs of (a) shallow pool habitat with limited instream habitat diversity at site RC2 on Rocky Creek; (b) poor riparian zone impacted by terrestrial weeds and hoop pine plantation at site RCT1 on a tributary of Rocky Creek; (c) dry channel with good riparian cover but a high proportion of Lantana at site RC1 on Rocky Creek; (d) hoop pines and lantana with no evidence of aquatic habitat at site TL1 on a tributary of Rocky Creek within the easement; (e) dry unmapped dam with some emergent aquatic plants at site TLD2 in the Rocky Creek catchment within the easement; and (f) large mapped lacustrine wetland with abundant aquatic plants at site RC4 on Rocky Creek

Within the transmission line easement, mapped tributaries of Rocky Creek assessed during the field survey in June 2019 (i.e. sites TL1, TL3, TL4, TL5 and TL6) did not have defined bed and banks, and no aquatic habitat was evident. These sites were not considered waterways and would likely only convey overland flows during periods of high rainfall. Most sites were highly disturbed by hoop pine plantations, with an understorey of lantana (Figure 2.4d). Two sites were located on unmapped dams that consisted of small, shallow depressions that were dry during the field survey (i.e. sites TLD1 and TLD2; Figure 2.4e). A summary of field observations completed at each site is in provided in Appendix A.

Rocky Creek and its tributaries within the Yarraman State Forest consisted of narrow drainage channels that were generally dry during the K2E surveys (ESP 2021). The only water present was within small, isolated farm dams. These dams were highly disconnected from surrounding waterways and contained very limited aquatic habitat, restricted to shallow pools with some woody debris and isolated aquatic plants growing high along the banks (typically not submerged, except when the water level was high following rainfall) (Figure 2.4a).

The dry channels of Rocky Creek and its tributaries were disturbed by surrounding land-uses, primarily the presence of hoop pine plantations, which impeded the riparian zone at some sites (Figure 2.4b). There was a high abundance of exotic terrestrial weeds (e.g. Lantana, *Lantana camara*) in the dry channel (Figure 2.4c). These channels are mapped as low to moderate confidence surface expression GDEs (State of Queensland 2022, BOM 2022), but would very rarely hold water, only acting as drainage channels to convey flows during significant rainfall events. Instream sediments were dominated by silt / clay, with small portions of sand.

Further downstream, where the channel widened, Rocky Creek contained isolated small pools that are fed mostly by groundwater. There was also a large mapped modified lacustrine wetland located on Rocky Creek approximately 6 km downstream of the Project that provided a dry season refuge for aquatic flora and fauna (Figure 2.4f). This wetland was a farm dam and was disconnected from downstream habitats and crossed the entire creek channel, and as such fish passage was restricted except during periods of high flow. The dam was highly disturbed by cattle access (which had trampled the banks causing erosion in some areas) and riparian vegetation had been largely cleared for grazing (therefore in-stream shading was limited). However, it provided shallow and deep pool habitats and contained a high abundance and diversity of aquatic plants and a small amount of woody debris. Although aquatic habitat condition at this site was low to moderate, it provided a dry season refuge for aquatic flora and fauna. This included refuge for large-bodied fish, for which the smaller pools within the creek channel did not provide adequate habitat.

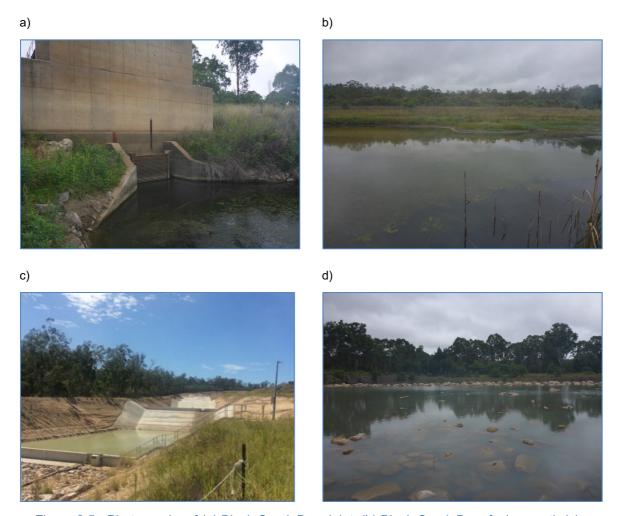
Figure 2.5 Photographs of (a) Black Creek Dam inlet; (b) Black Creek Dam facing south (c) concrete section in Black Creek diversion channel (d) constructed pool in Black Creek diversion channel.

Black Creek has been substantially modified from its natural state along most of the waterway. There are large persistent pools in some areas (particularly dams and in the constructed channel), but Black Creek has very poor connectivity to downstream waterways of Meandu Creek (Figure 2.5). The riparian vegetation is impacted by vegetation clearing associated with the adjacent land uses and the construction of the Black Creek Dam and Black Creek diversion channel. While Black Creek Dam provides some habitat for aquatic flora and fauna, the habitat is entirely engineered in the constructed channel downstream of Black Creek Dam. Black Creek Dam and the constructed channel have limited features, with little bank vegetation (except for some scattered aquatic plants around the dam) or in stream habitat features providing structural complexity and shelter for aquatic fauna (although boulders, cobbles, pebbles and gravel in some areas of the waterway provide come structural complexity: Figure 2.5d). Waterways and riparian vegetation within Meandu Creek were generally impacted by industrial land use, agricultural land use, hydrological change, riparian degradation, and / or weed infestation. Regardless of these impacts, instream habitat availability and diversity were typically good downstream of Meandu Creek Dam (including trailing bank vegetation, a variety of instream aquatic plants and woody debris).

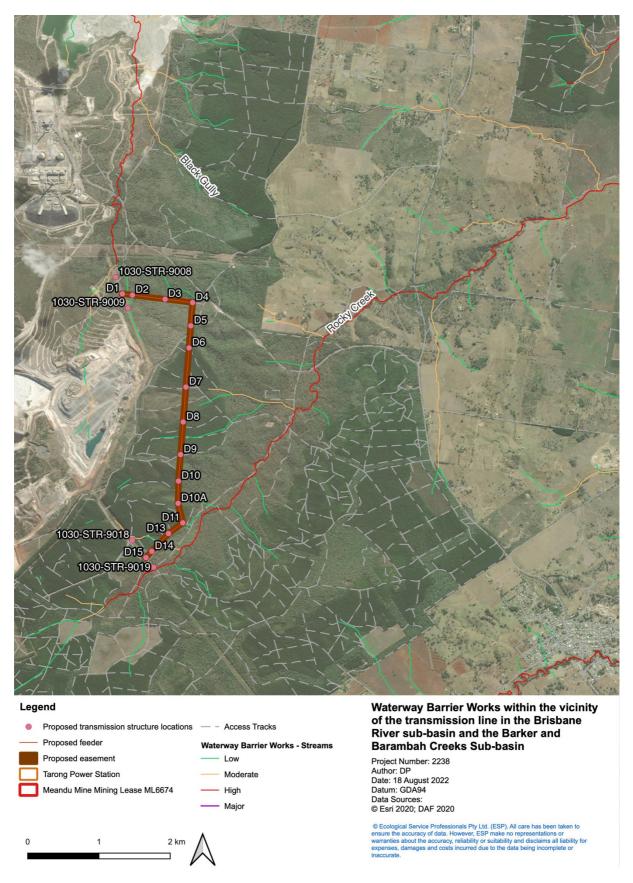
Figure 2.6 Waterway Barrier Works mapped in the vicinity of the Project

The waterways in the vicinity of the Project are mapped as the following risk of adverse impact to fish movement from waterways barrier works in the DAF Queensland Waterways for Waterway Barrier Works spatial layer (Figure 2.6):

- Tributaries of Rocky Creek in the vicinity of the Project are mapped as low (green) and moderate (amber) risk, whereas Rocky Creek downstream of the Project is mapped as a high (red) risk.
- Tributaries of Black Creek are in the vicinity of the Project are mapped as low (green), whereas downstream of the Meandu Mine mining lease boundary Black Creek to Meandu Creek is mapped as moderate (amber) risk and high (red) risk.

The preferred alignment crosses three mapped waterways for waterway barrier works, including (refer to Figure 2.6):

There may also be waterway crossings associated with upgrading existing tracks, with the exact location of upgrades yet to be determined. However, there will be no upgrades to Rocky Creek proper, which is mapped as a high (red) risk (refer to Figure 2.6). As such waterway crossings associated with upgrading existing tracks will only occur on the mapped low (green) and moderate (amber) risk waterways to the west of Rocky Creek proper (refer to Figure 2.6). Sites assessed in this area (along the easement) in July 2019, did not contain any aquatic habitat, and had no defined bed or banks; as such, they were considered drainage depressions that would only convey overland flow during periods of high rainfall. Two unmapped dams within the easement were also assessed during the field survey, which consisted of small, dry depressions and contained limited aquatic habitat (emergent aquatic plants at one site only). As such, fish passage is likely to be limited in these green and amber waterways in the headwaters of Rocky Creek due to the ephemeral nature of the waterways, and they unlikely to connect to any important breeding, feeding or refuge area further upstream.

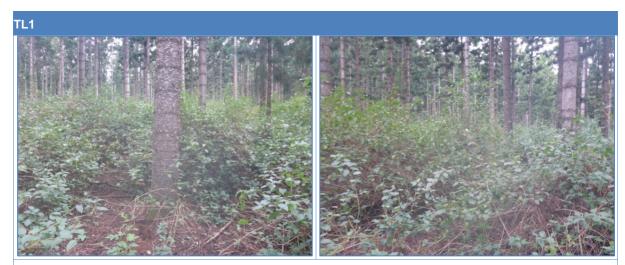
**General comments:** Located on a mapped tributary of Rocky Creek within the easement. This site was dry at the time of the sampling event in June 2019 and was characterised as a drainage depression with no defined channel, bed or banks, likely conveying overland flow only during sustained high rainfall periods. Aquatic habitat condition and value were poor.

No banks were evident so the riparian zone was undefined. Vegetation was continuous along the waterway, and consisted of hoop pine plantation with an understory of lantana. The site was highly disturbed by external influences including terrestrial weeds and forestry operations.

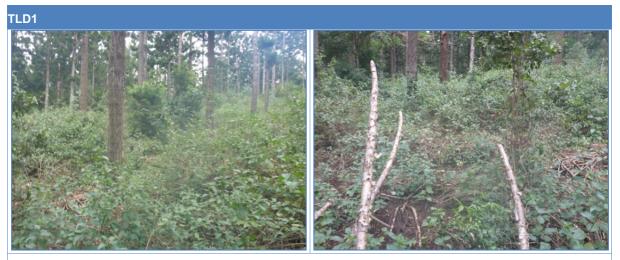
**General comments:** Located on an unmapped dam in the Rocky Creek catchment immediately adjacent to the easement. This site was dry at the time of the sampling event in June 2019 and was characterised as a small, shallow depression with no permanent water. Aquatic habitat condition and value were poor.

No banks were evident so the riparian zone was undefined. Vegetation was continuous around depression, and consisted of hoop pine plantation with an understory of lantana. The site was highly disturbed by external influences including terrestrial weeds and forestry operations.

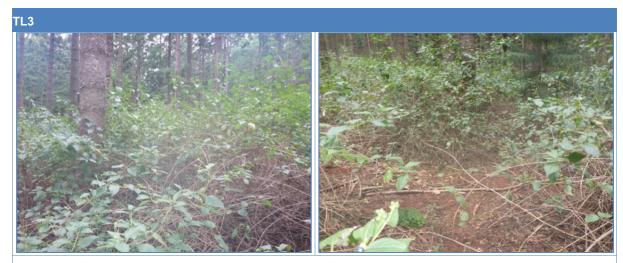
**General comments:** Located on a mapped tributary of Rocky Creek within the easement. This site was dry at the time of the sampling event in June 2019 and was characterised as a drainage depression with no defined channel, bed or banks, likely conveying overland flow only during sustained high rainfall periods. Aquatic habitat condition and value were poor.

No banks were evident so the riparian zone was undefined. Vegetation was continuous along the waterway, and consisted of hoop pine plantation with an understory of lantana. The site was highly disturbed by external influences including terrestrial weeds and forestry operations.

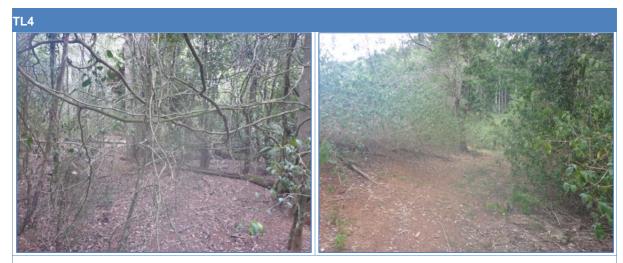
**General comments:** Located on a mapped tributary of Rocky Creek within the easement. This site was dry at the time of the sampling event in June 2019 and was characterised as a drainage depression with no defined channel, bed or banks, likely conveying overland flow only during sustained high rainfall periods. Aquatic habitat condition and value were poor.

No banks were evident so the riparian zone was undefined. Vegetation was continuous along the waterway, and consisted of native forest and hoop pine plantation with an understory of lantana in some areas. The site was highly disturbed by external influences including terrestrial weeds and forestry operations.

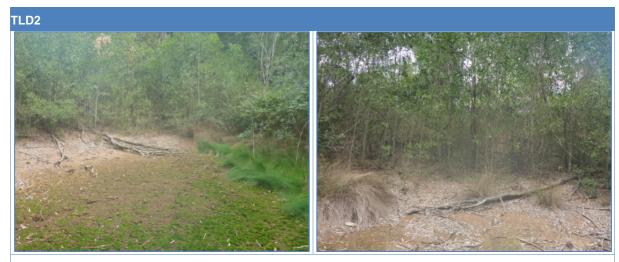
**General comments:** Located on an unmapped dam in the Rocky Creek catchment within the easement, adjacent to site TL4. This site was dry at the time of the sampling event in June 2019 and was characterised as a small, shallow depression with no permanent water. Aquatic habitat condition and value were poor.

Riparian vegetation was continuous around depression, and consisted of native forest with an understory of lantana in some sections. The site was highly disturbed by external influences including terrestrial weeds and nearby forestry operations.

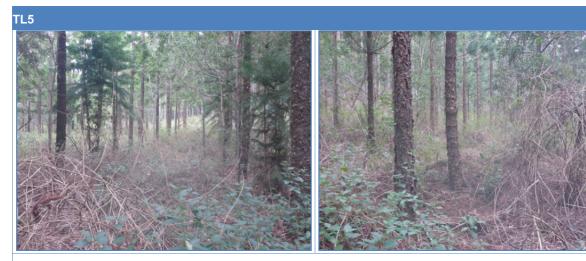
**General comments:** Located on a mapped tributary of Rocky Creek 30 m north-west of the current easement (on the previous alignment). This site was dry at the time of the sampling event in June 2019 and was characterised as a drainage depression with no defined channel, bed or banks, likely conveying overland flow only during sustained high rainfall periods. Aquatic habitat condition and value were poor.

No banks were evident so the riparian zone was undefined. Vegetation was continuous along the waterway, and consisted of hoop pine plantation with an understory of lantana. The site was highly disturbed by external influences including terrestrial weeds and forestry operations.

| Site | Description | Latitude | Longitude |
|---|--|---|---|
| TL5 | Located on a mapped tributary of Rocky Creek 30 m north-west of the current easement (on the previous alignment) | -26.8268° | 151.9303° |

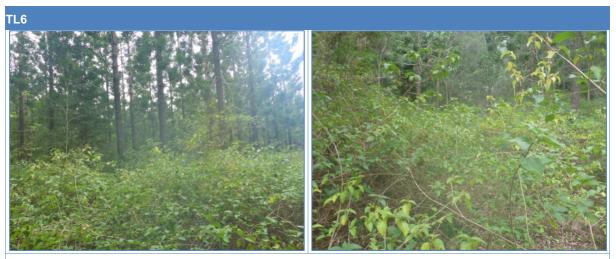
**General comments:** Located on a mapped tributary of Rocky Creek 80 m north-west of the current easement (on the previous alignment). This site was dry at the time of the sampling event in June 2019 and was characterised as a drainage depression with no defined channel, bed or banks, likely conveying overland flow only during sustained high rainfall periods. Aquatic habitat condition and value were poor.

| Site | Description | Latitude | Longitude |
|---|--|---|---|
| TL6 | Located on a mapped tributary of Rocky Creek 80 m north-west of the current easement (on the previous alignment) | -26.8285° | 151.9277° |
